## **THE CORPORATION OF THE TOWNSHIP OF SOUTHGATE**

### **PROPERTY SALE**

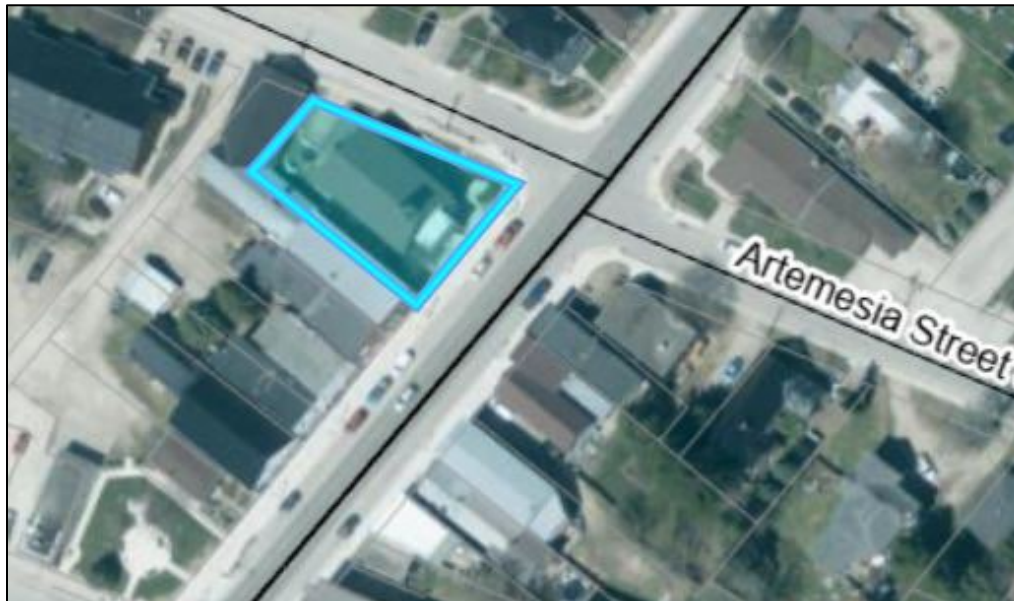
The property is being sold in an "as is" condition, without any representations or warranties from the seller. The buyer agrees to take the property title "as is" and should therefore do their own due diligence prior to submitting an Offer to Purchase.

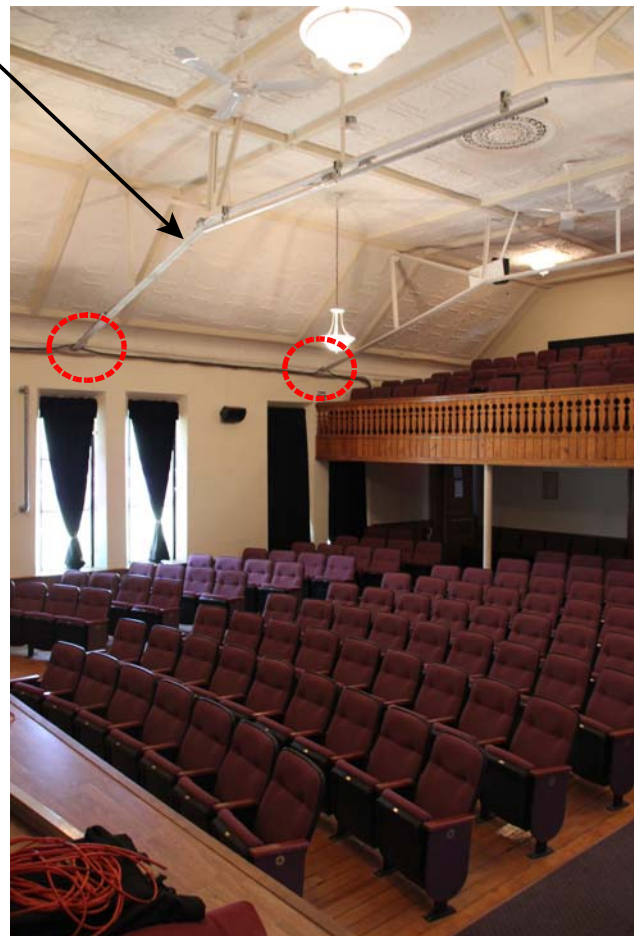
Performance Hall auditorium with exposed portion of steel trusses at ceiling.

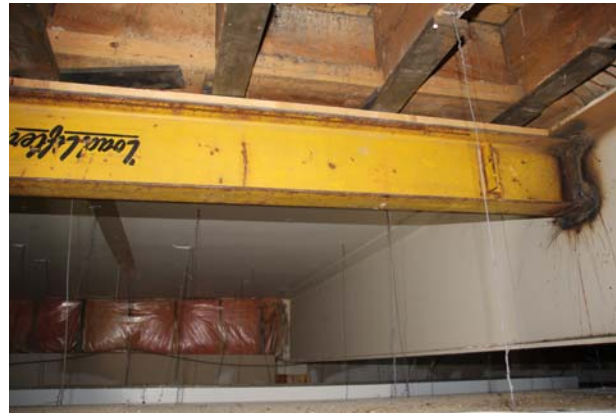
24" deep (white coloured) steel beam spans width of building, supporting 2<sup>nd</sup> floor structure. Yellow beam was added to support failed wood beam directly above.

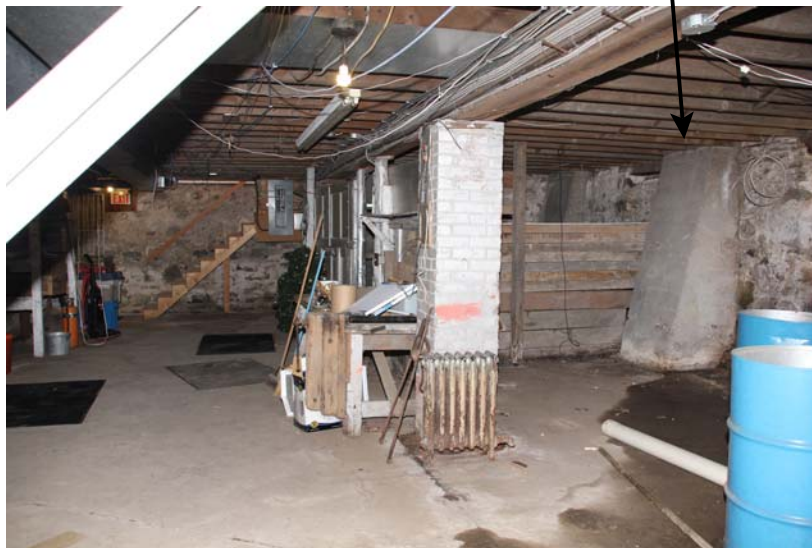
Basement, looking south.

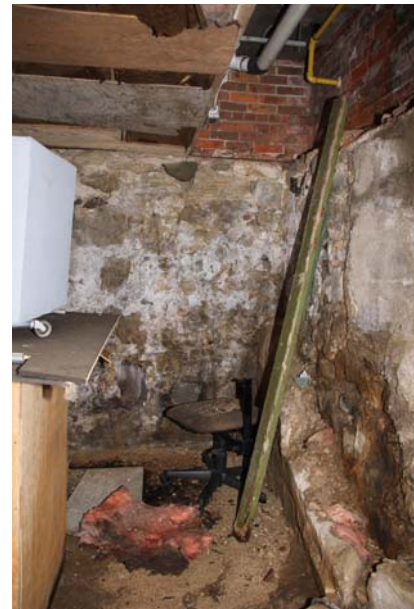
Northwest basement corner is very damp due to disconnected exterior rainwater leader draining eave gutter. Note the accumulation of mortar fines primarily at toe of foundation wall.

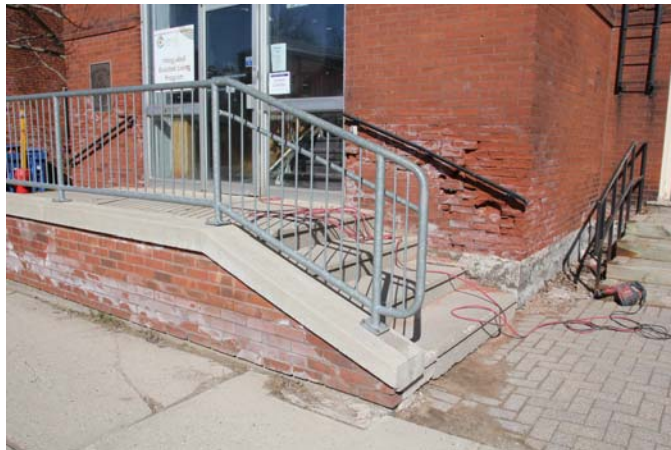
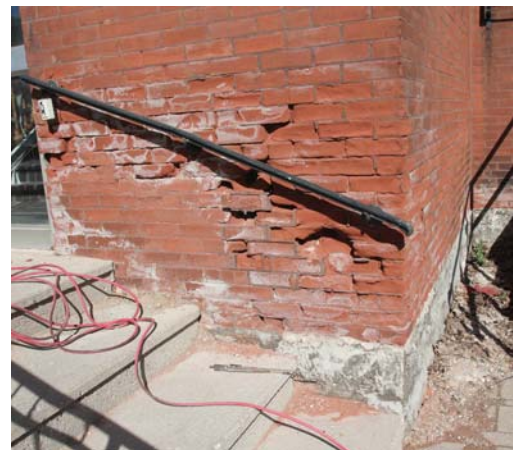
Invasive testing was conducted at south wall of entry lobby, involving removal of a small quantity of brick units. This testing verified that brick is heavy with water content and mortar fragments are damp enough to form a ball. Damp brick and mortar were evident at second wythe of wall, in addition to outer wythe. It is recommended that the outer wythe of brick in this area be removed and replaced with cut stone units or manufactured concrete products that can better tolerate these conditions. A damp-course membrane should be provided between new stone/concrete material and remaining brick masonry, to prevent moisture migration. Chloride-free deicing products are recommended for stairs and landing.

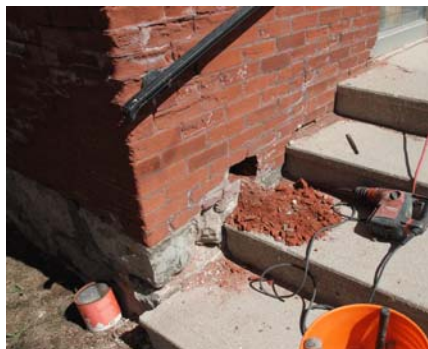
Observation port at west side of stairs.

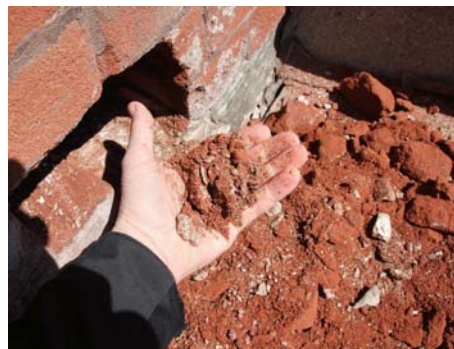
Mortar removed from joint is moist enough to clump and hold under hand pressure.

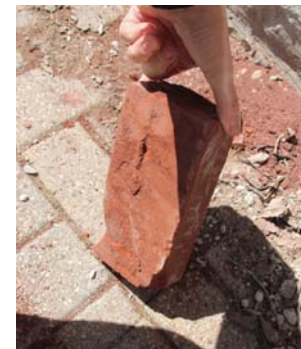
Brick units were heavy with moisture but in reasonable condition.

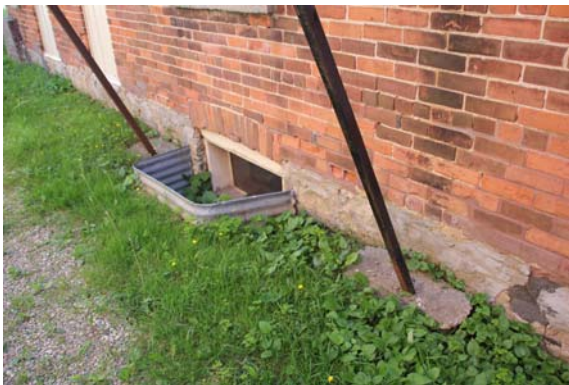
Stone foundation wall requires mortar pointing.  
Diagonal steel members, supporting fire escapes, are under structured.

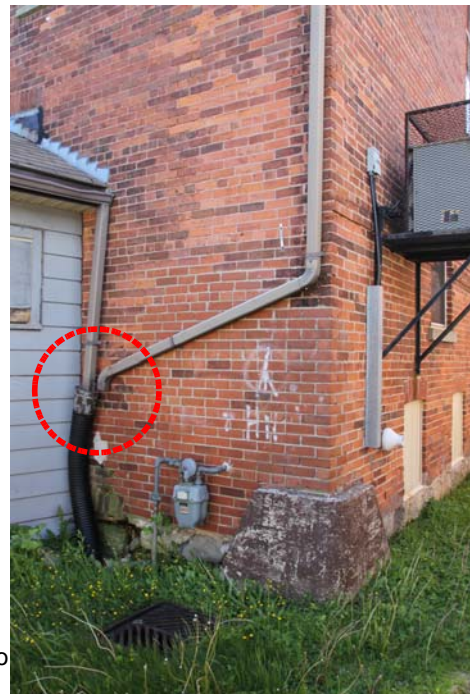
Rainwater leaders are not connected to drain pipe resulting in saturation of wall masonry and deterioration of foundation wall. This area of wall has been subject to previous repairs.

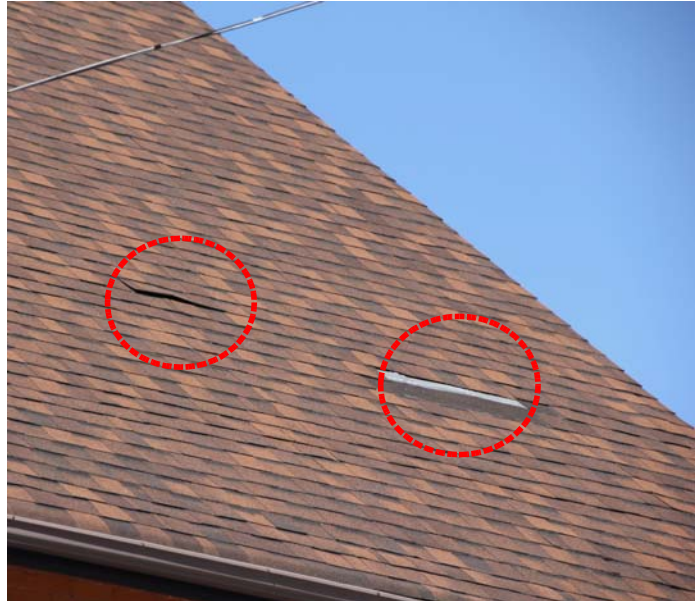
Some shingles had been blown from the roof and others were lifted, by late winter storms. White colour, visible at absent shingle location, is the membrane underlayment now exposed to the sun.

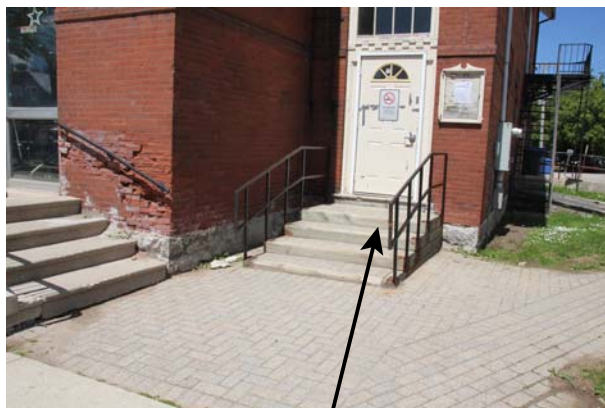
Non-compliant exterior stairs.

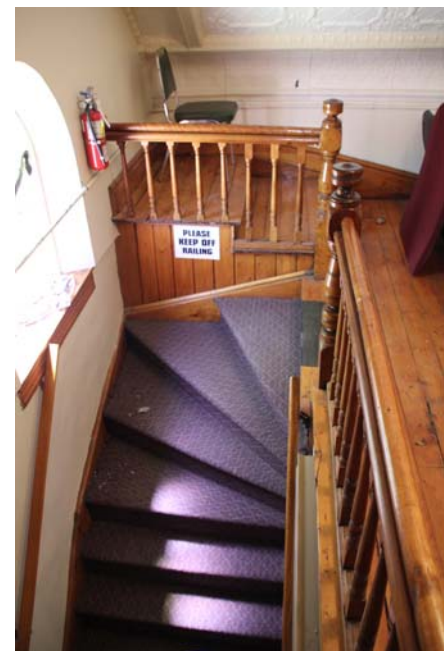
Balcony stair with curved winders and non-complaint guard around balcony opening.

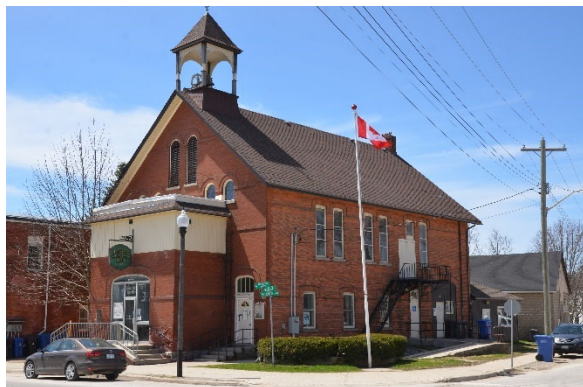
Front (South) Elevation

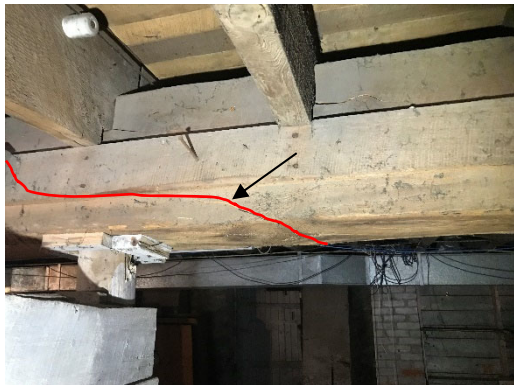
Solid sawn beams are deficient in required strength.

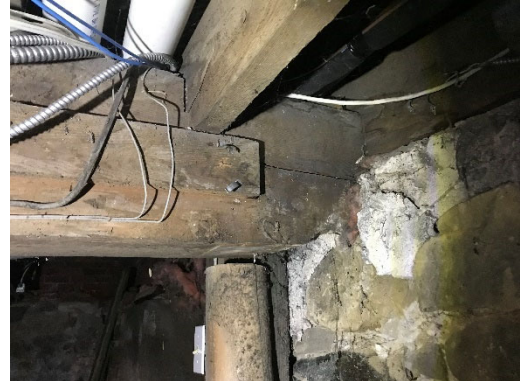
North Wall Beam Bearing

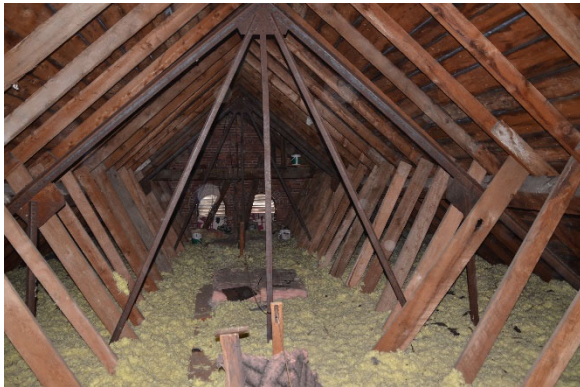
Attic Roof Truss Elevation  
*Steel riveted connections*

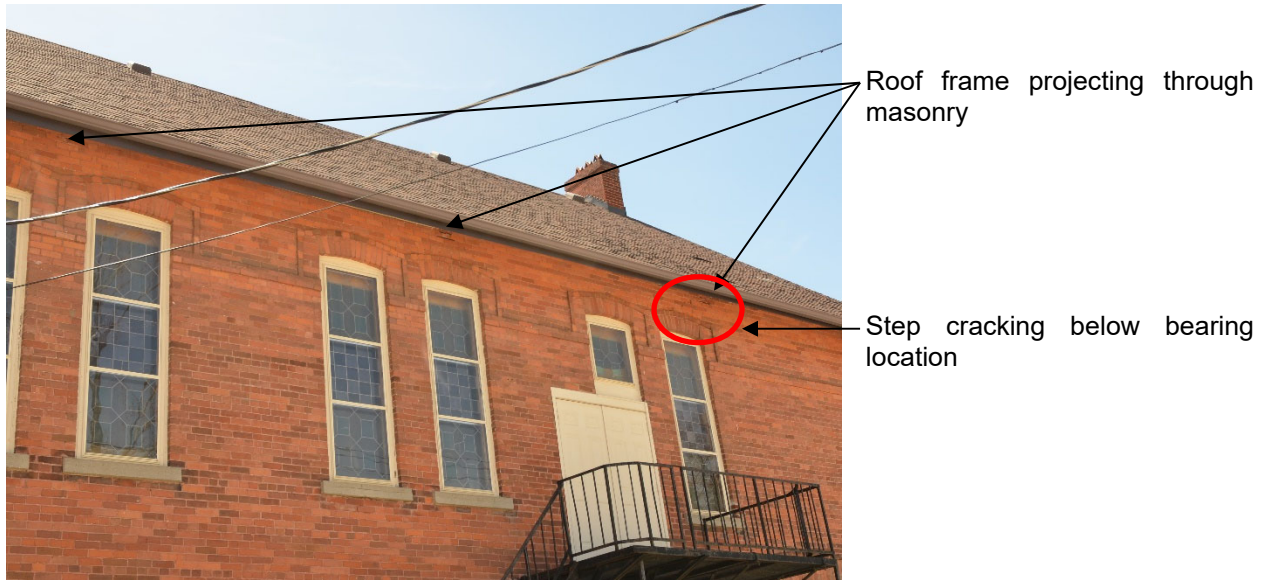
Repairs including reinforcing of the masonry in these locations is required and is recommended to be completed in the short term.

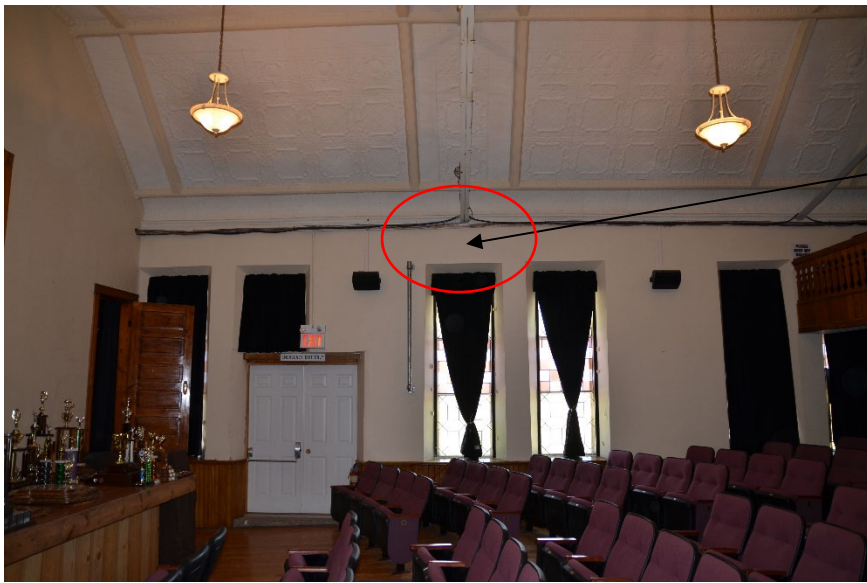
Truss bearing above window location. No apparent interior distress was noted

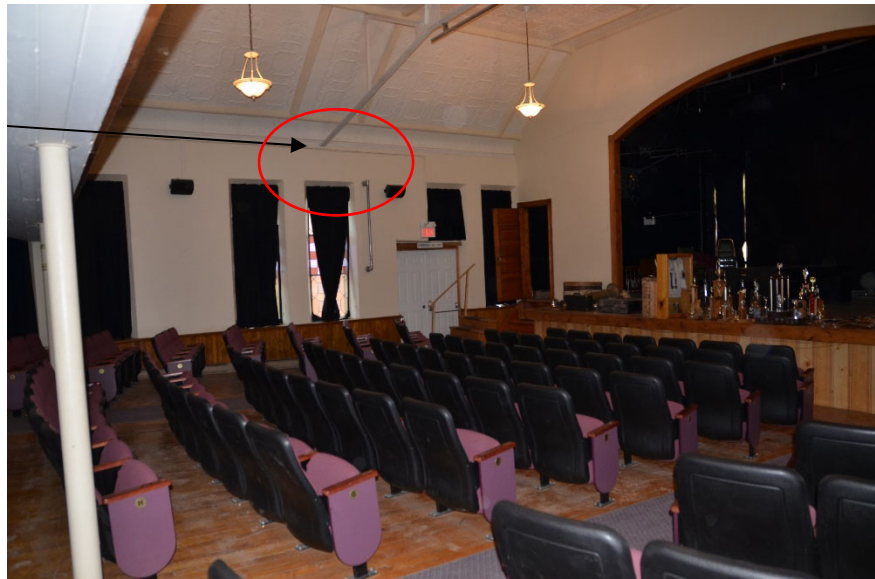
Frame 3 Interior Elevation – West Wall

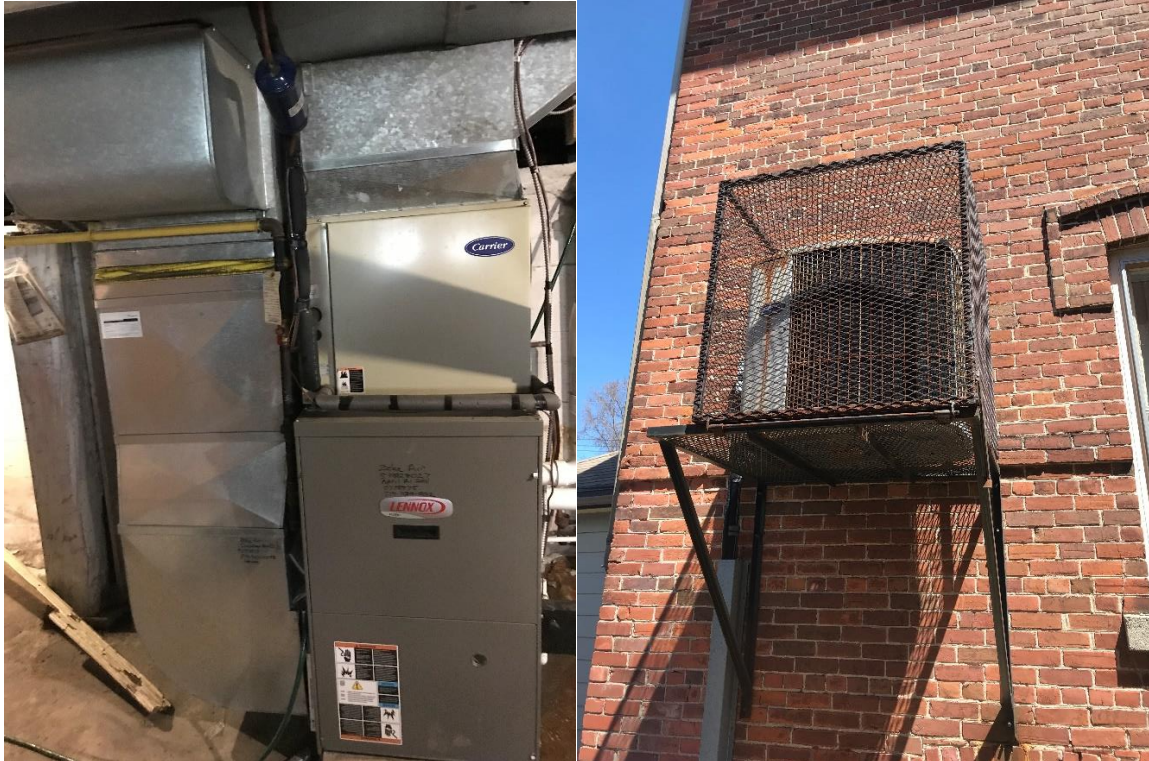
Figure 2: Furnace and Condensing Unit

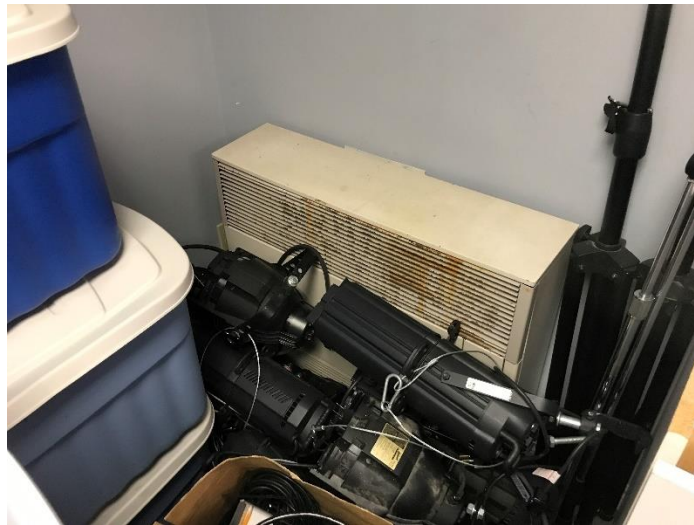
Figure 3: Unit Ventilator

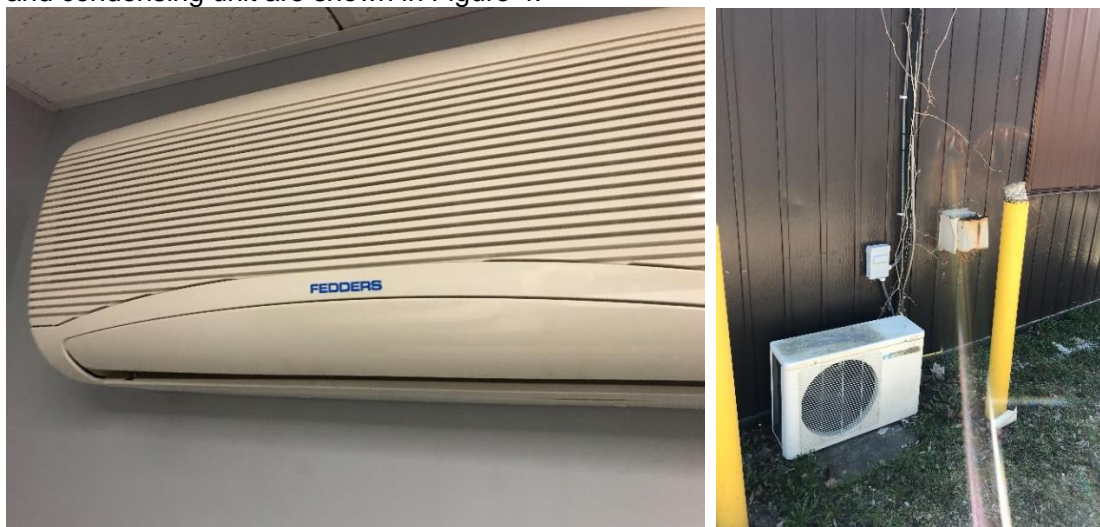
Figure 4: Addition Air Conditioning Unit
